# HURRICANE HELENE FLOOD RECOVERY AND COMMUNITY RESOURCES UPDATE WAYNESVILLE TOWN COUNCIL

OCTOBER 8, 2024

# POST-STORM DAMAGE ASSESSMENT

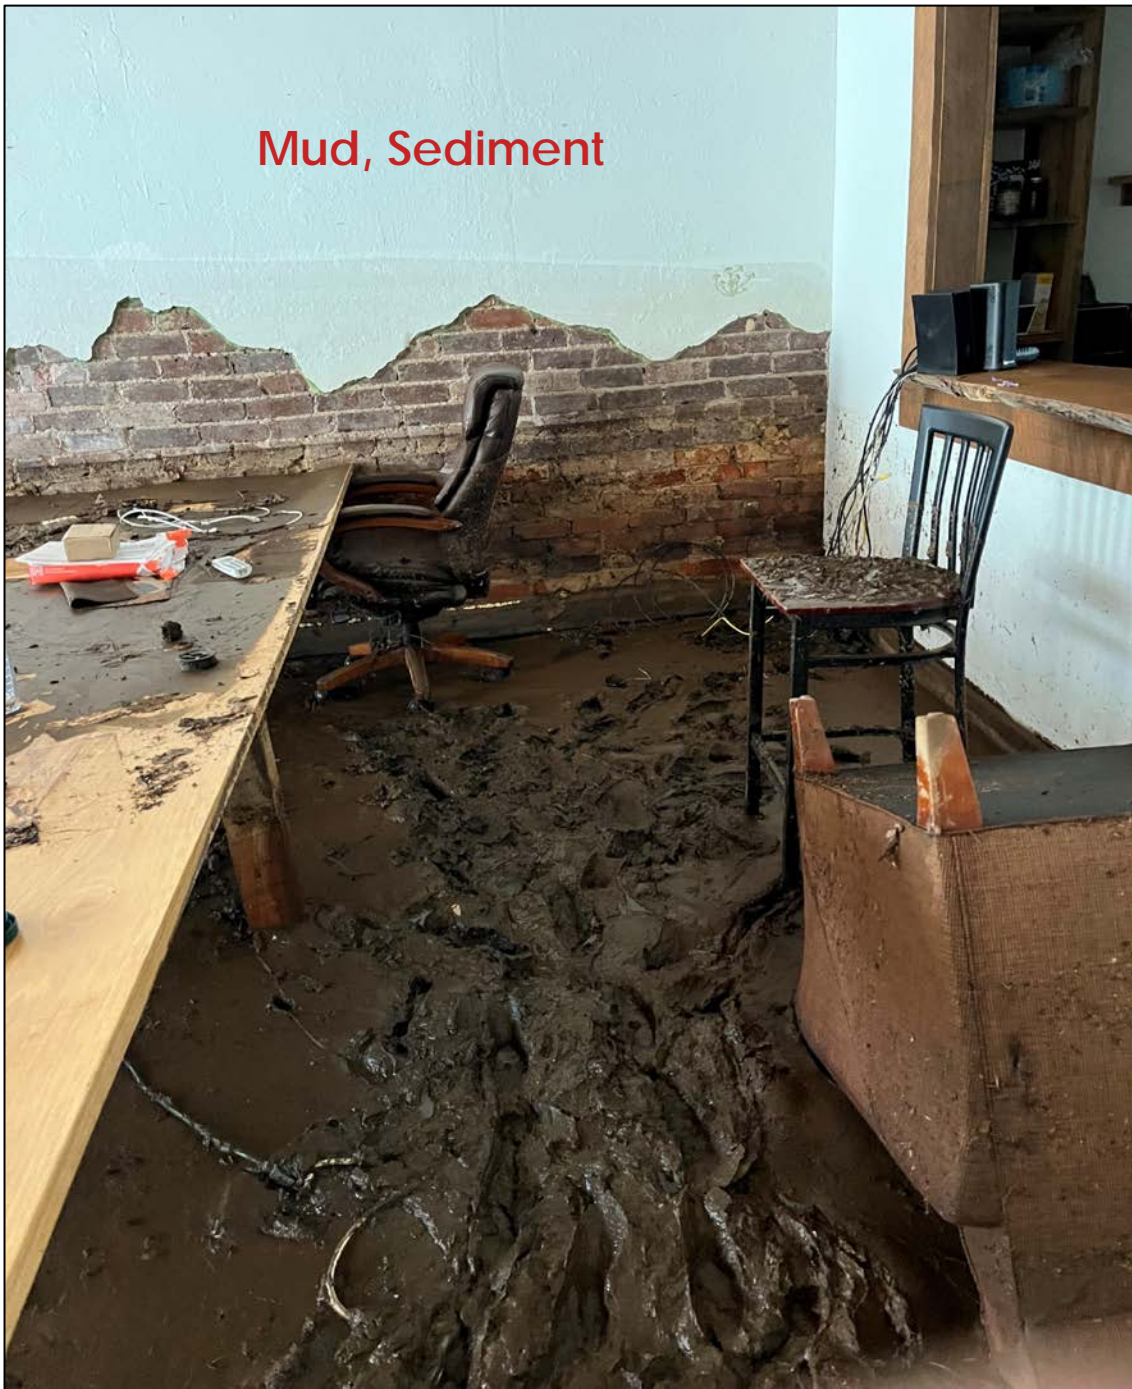
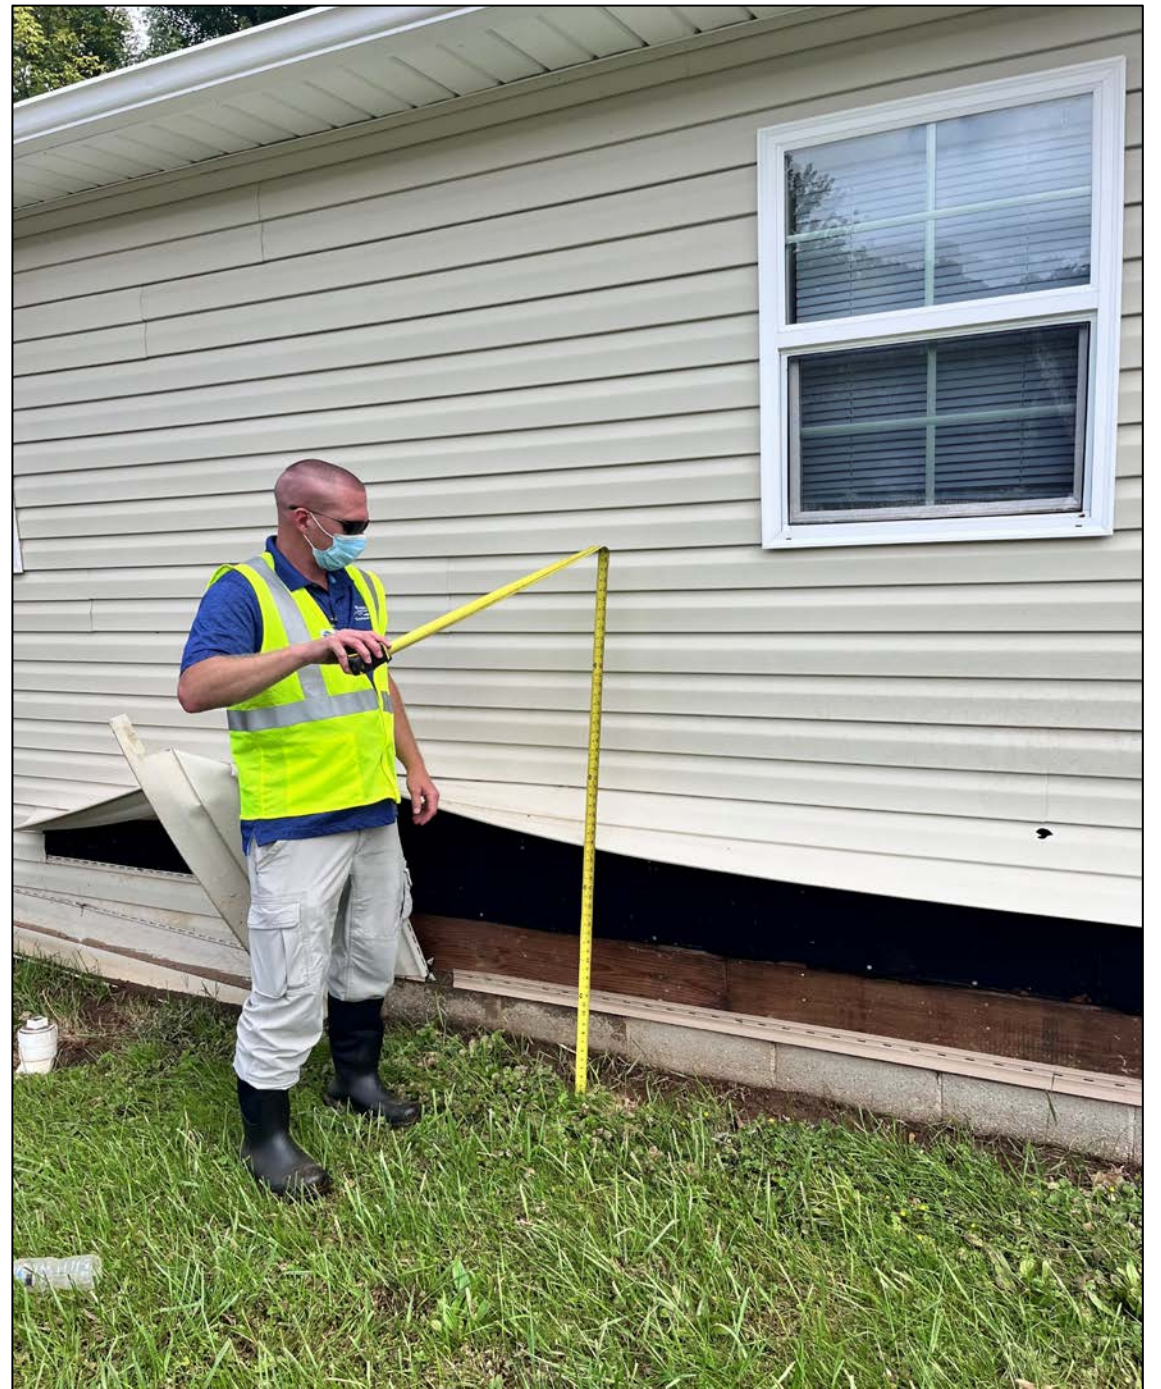
Mud, Sediment

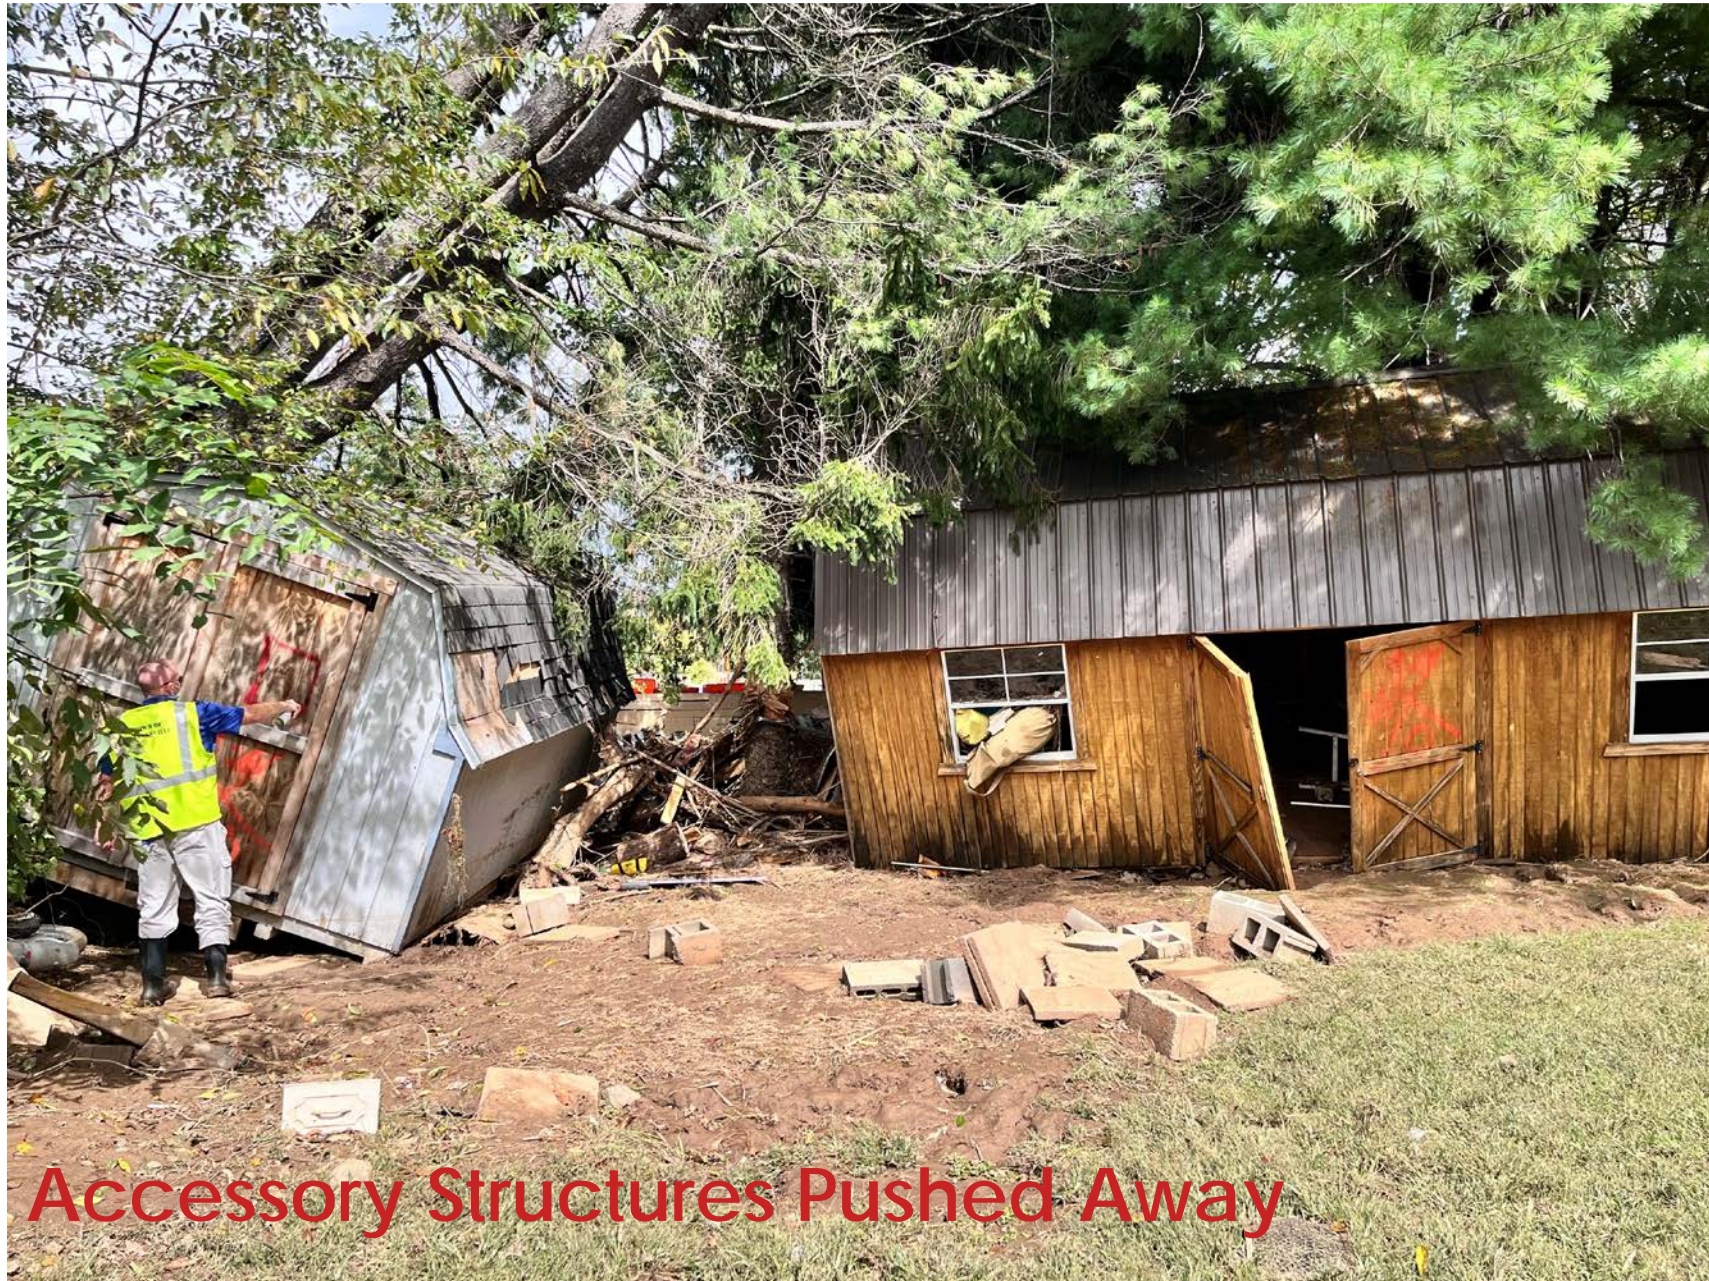
Accessory Structures Pushed Away

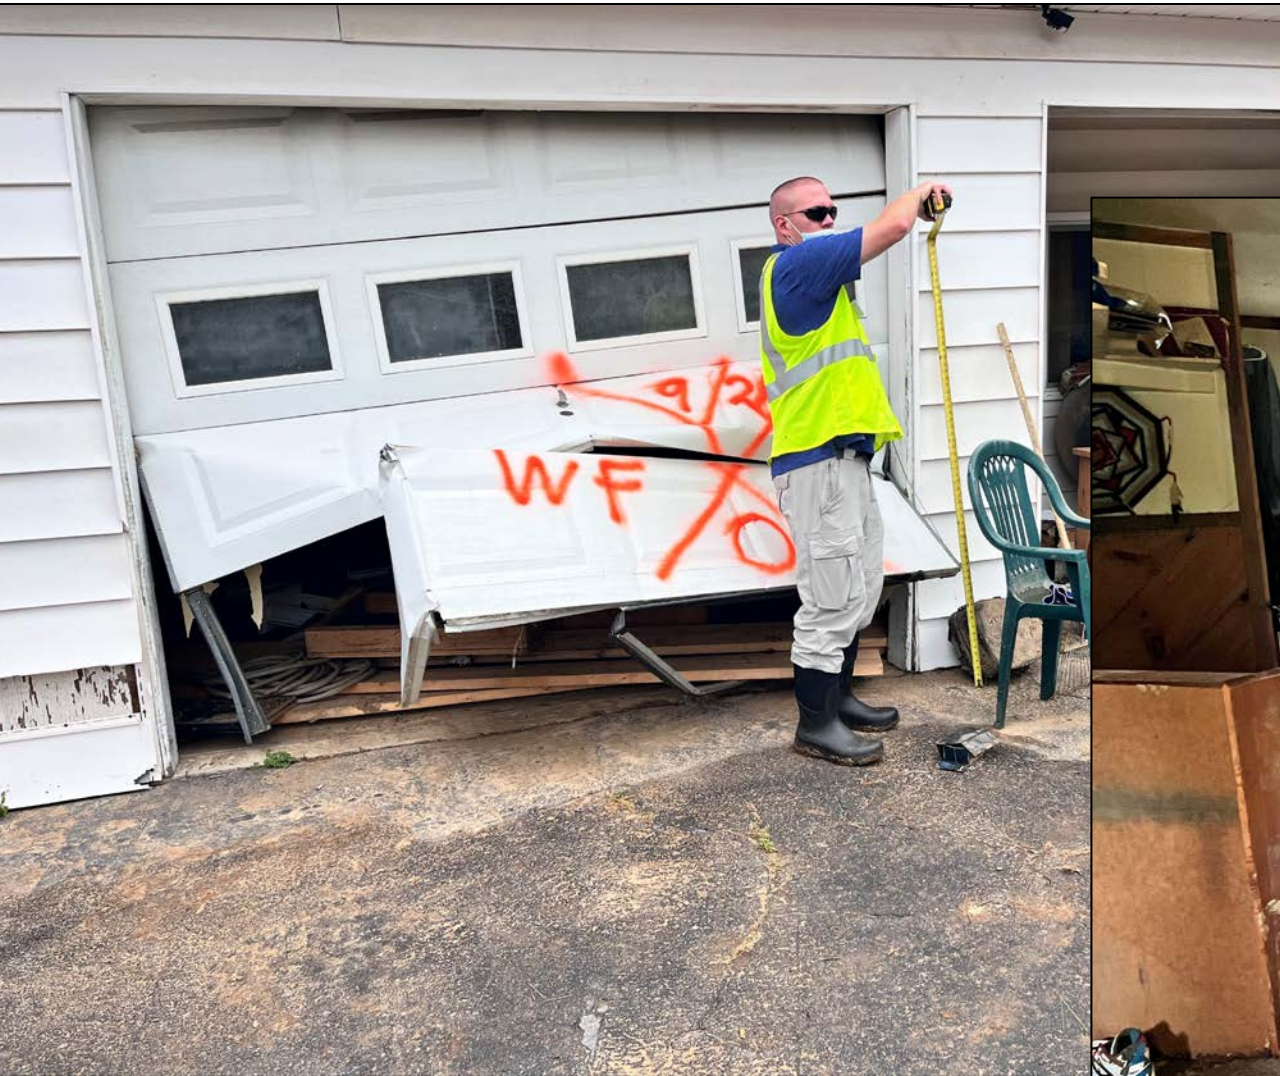
Mud, Sediment

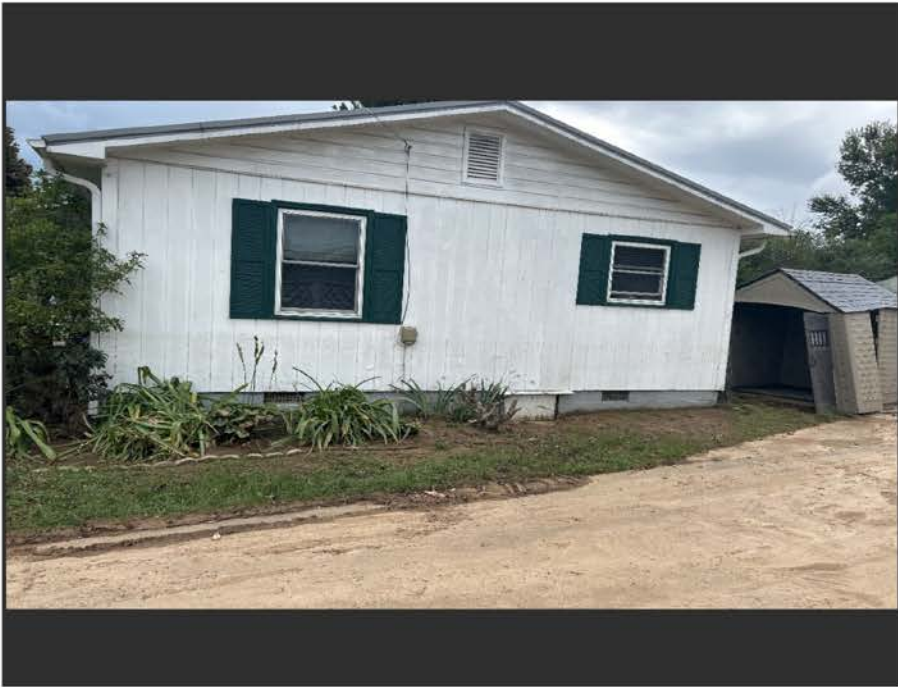
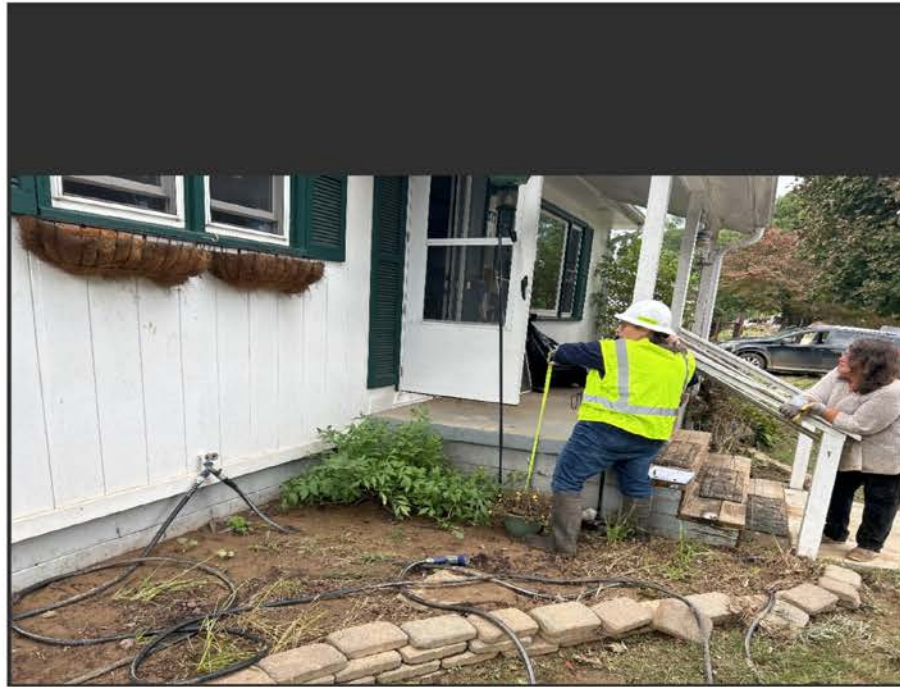
High Water Marks

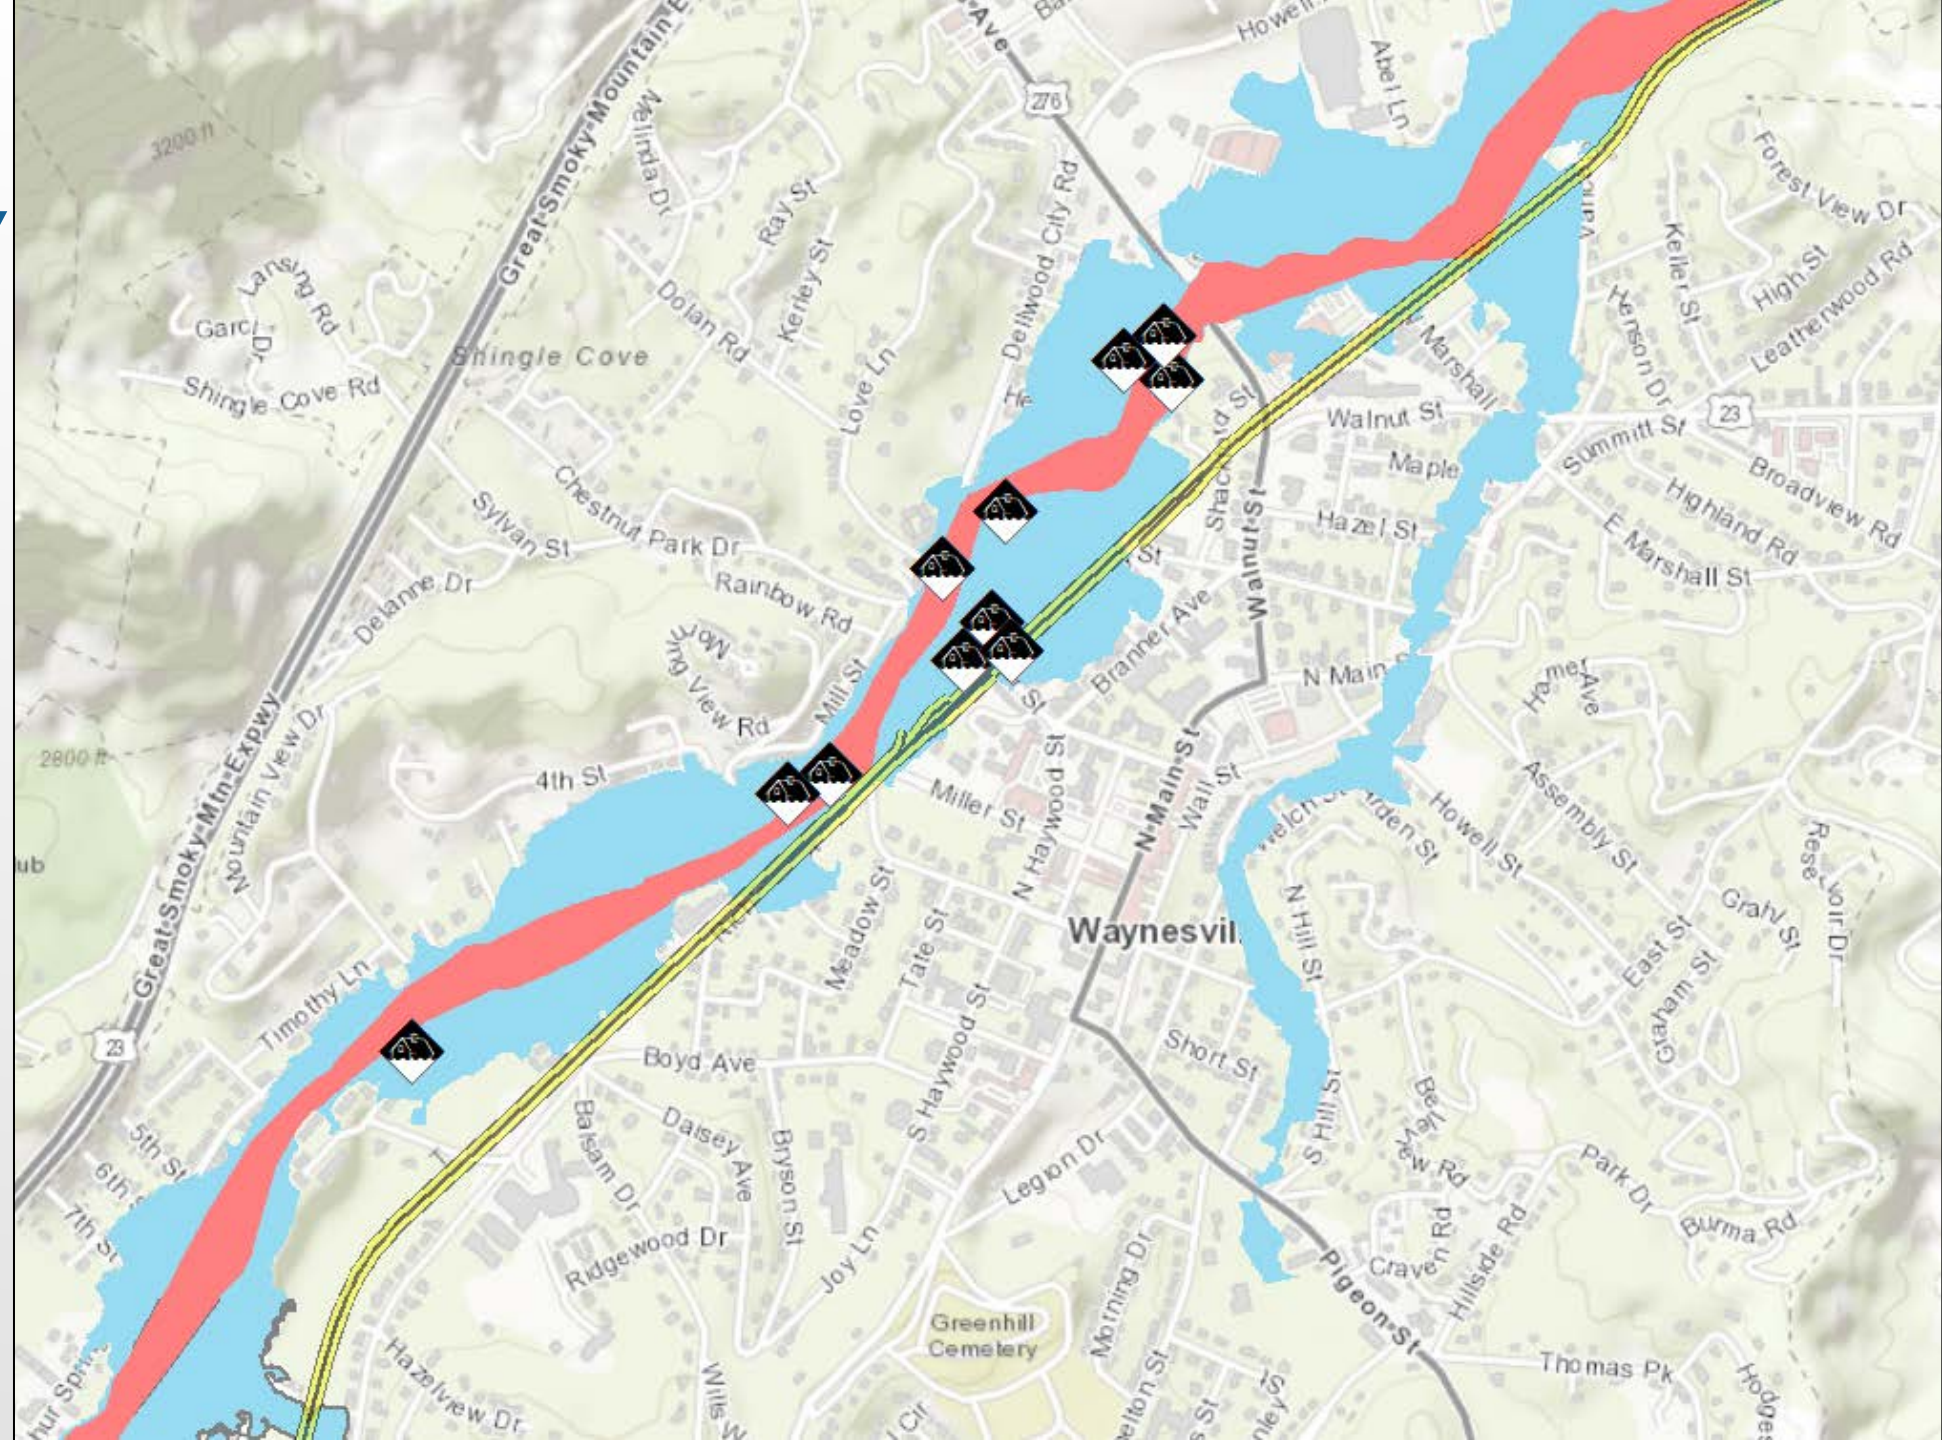
# SUBSTANTIALLY DAMAGED STRUCTURES

- **All 12 Substantially Damaged structures were in the 100-year floodplain, and 4 of them in the floodway.**
- **Substantially damaged structures had water marks ranging from 1 to 5 ft.**
- **Substantially damaged structures must be brought into compliance with flood elevations or with flood proofing.**
