Importance of Water in Morphology

Abstract. Numerous huge landslides and a lot of springs are located in Ecemiş Fault Zone between Adana and Niğde, in the south of Turkey. The water-discontinuity-clay trinity plays a significant role in the formation of these landslides and morphology of the area. A large-scale dam and a highway were planned in this valley where is highly rich in terms of flora and fauna and composed by huge slopes. This study showed that the water in the area is meteoric and one of the main cause of landslides. Any big project can cause many geotechnical problems with remedial works. Because, the safety coefficient of huge landslides is 1 which means their stability is critical and any operation will disrupt this balance. Because of this and/or similar geotechnical problems; the projects were canceled. Besides, water is potable and suitable for irrigation and the valley stands as national wealth.

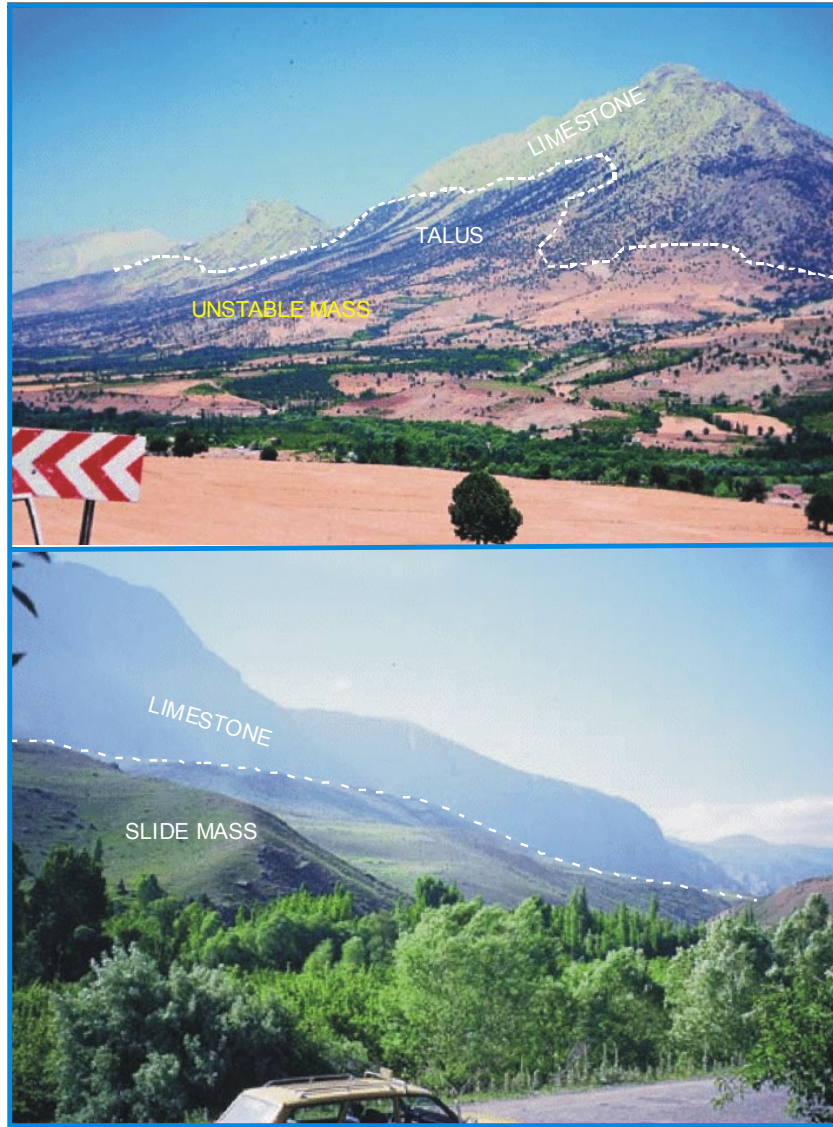
Figure 2. Slide masses in Ecemiş Fault Zone.

The study area is a hallway with about 60 km long and 0.5 - 5 km width between Adana and Niğde, is located in Ecemiş Fault Zone which is one of the important tectonic places in Turkey (Figure 2). The zone was formed between Paleocene and Lutetian. The main fault has a direction with N20E, left-lateral, vertical strike-slip. The second major fault in the study area is Cevizlik Fault which is more or less parallel to the Ecemiş Fault.

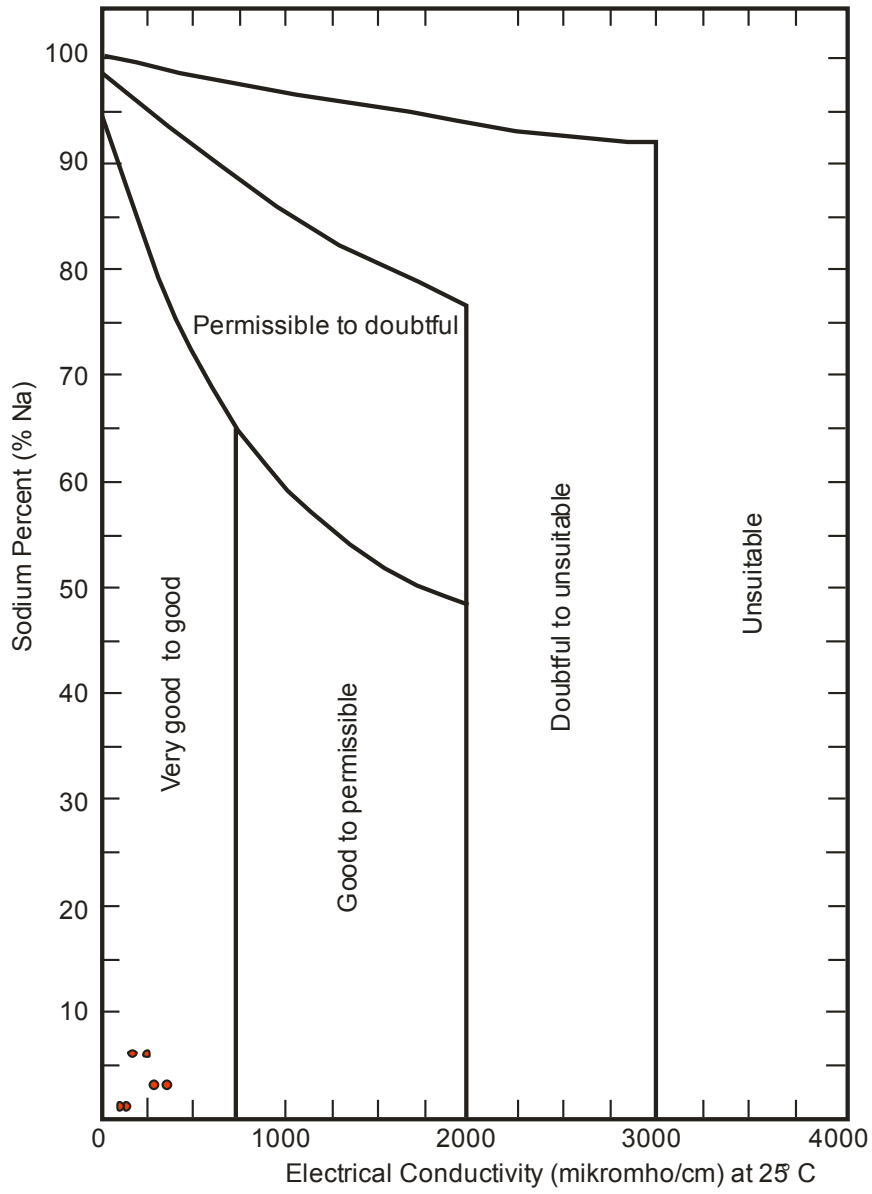
Excess of dissolved ions in irrigation water affect plants and soil by physical and chemical ways and reduce the yield. These ions cause to reduce the osmotic pressure in the cells of the plant and the water can not reach to the branches and leaves; then they disrupt the metabolism of plants. Therefore, Wilcox (Figure 7) and U.S. Salinity Laboratory (Figure 8) diagrams were used to determine the chemical properties of water in the study area, due to be evaluated in terms of agriculture. However, first SAR and % Na values were determined in these diagrams (Table 6).

Fig. 7. Water classification according to Wilcox.

4. The Schoeller diagram used in the study area demonstrated that water is drinkable.
5. According to the Wilcox diagram, water is classified as "very good-good" for agricultural usage.
