# Heuliez Bus (GX 337 CP) - Rescue Sheet

Heuliez Bus (GX 337 CP)

start of production in 2023

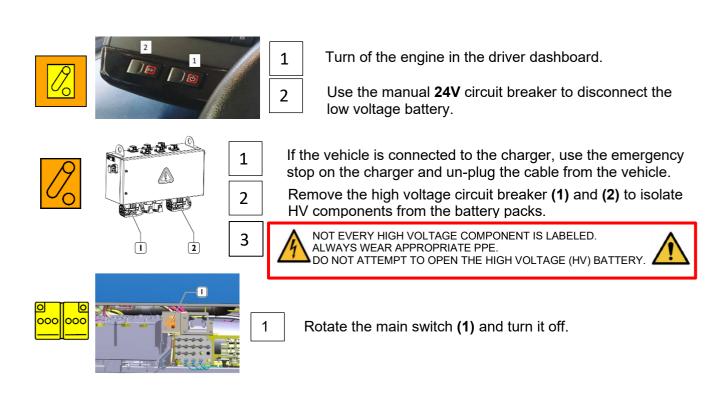
## 3. Disable direct hazards / safety regulations

If it necessary to cut the body structure to assess the occupants **never cut** orange high voltage cables.
