Training Modules for Guidance for Stream Restoration with Associated Wetlands

Module 3:

Use of the Ecological Integrity Assessment for Key Wildlife Habitats

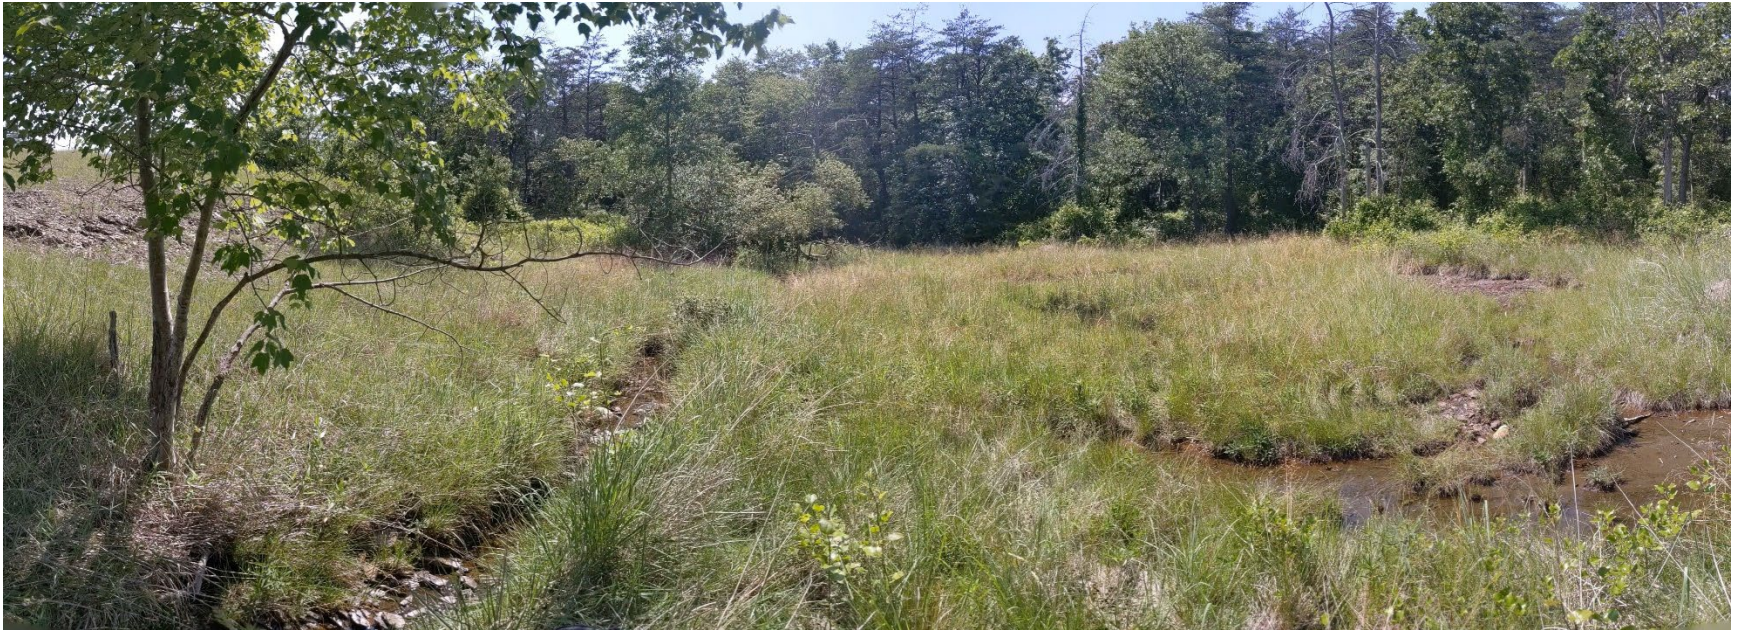
Photo: DNR

Example of a Piedmont Seepage Wetland with Good-Excellent hydrology and vegetation, with bonus points assigned for other values including being a nontidal wetland of special State concern, targeted ecological area, trout stream

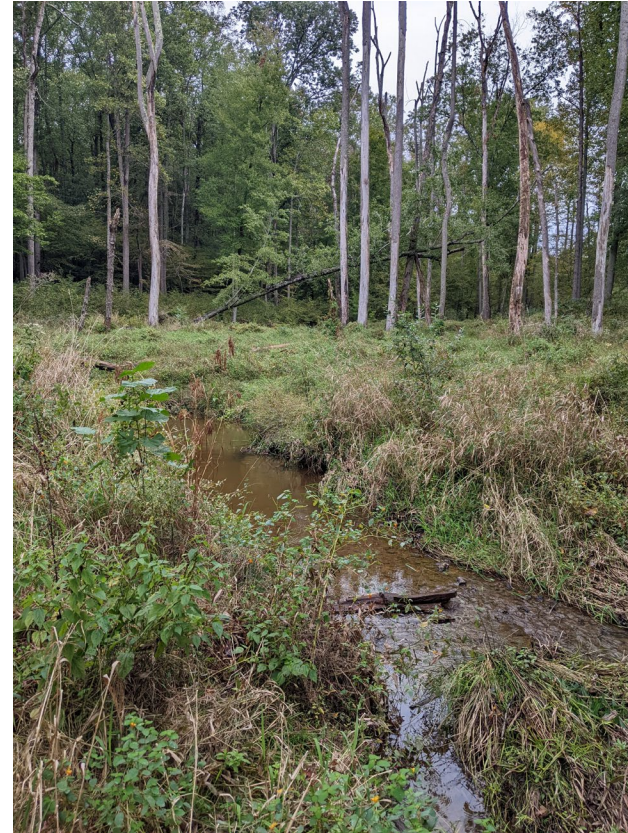
Photo: DNR

Example of channel in good condition, but only a fair vegetation community

- Hydrology channel and/or connectivity scores are “Excellent – Good”
 - Stream still floods riparian area frequently and the channel and banks show no or minimal instability and erosion
 - and
 - Overall Plant Community/Habitat “Fair-Poor”
- Add enhancements in the form of plantings or removal of invasive species in the riparian/wetland area.
- Add additional habitat features which may be lacking.

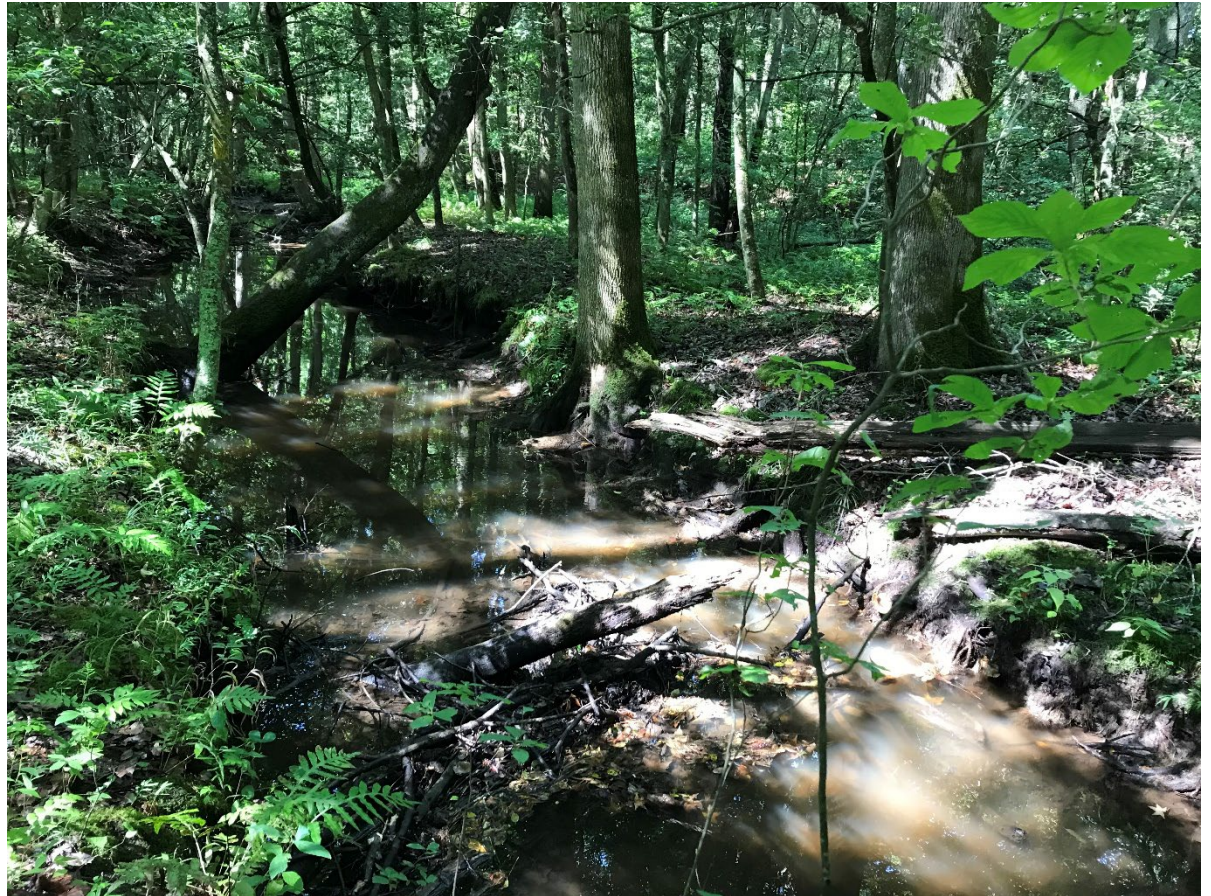
Photo: DNR

Channel in fair condition and showing some disconnection from floodplain. Floodplain vegetation in excellent condition.

- Hydrology scores for channel and/or connectivity are “Fair”
 - Stream still floods riparian area occasionally and there is moderate channel instability and bank erosion
 - and
 - Overall Plant Community/Habitat “Excellent - Good”
- cont.
- Minor changes, if any, in riparian area
- Post-construction water levels should generally mimic hydroperiod of the soil

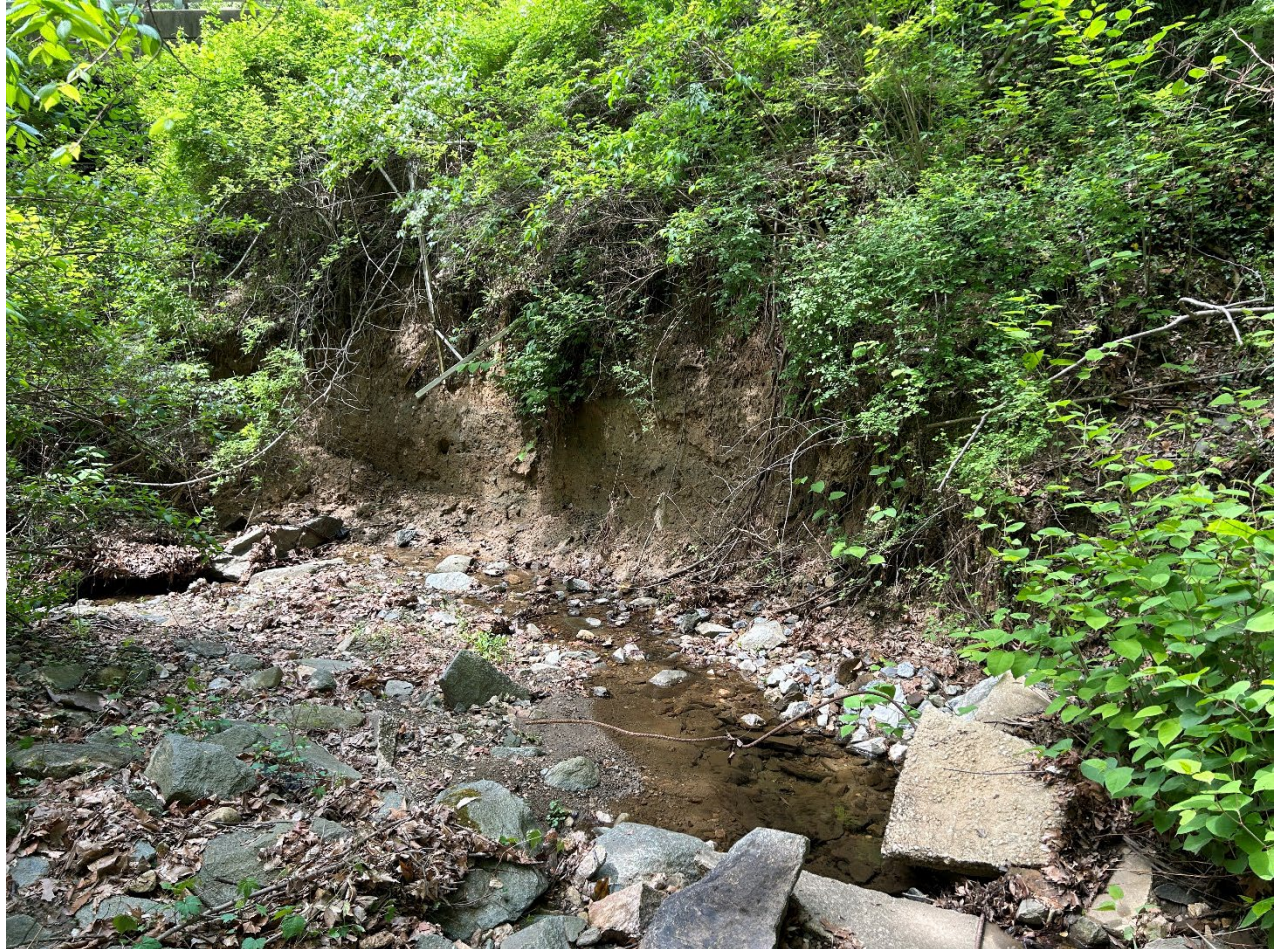
Photo: DNR

Here is an example of a channel with a section in poor condition.
